**Flood Control Project Maintenance
Levee Inspections**

Fall 2019 Levee Maintenance Deficiency Summary Report

Sacramento River Basin

**Flood Control Project Maintenance
Levee Inspections****LMA District Cover Sheet****Fall 2019 Levee Inspection Results****Reclamation District No. 0787 Fair**

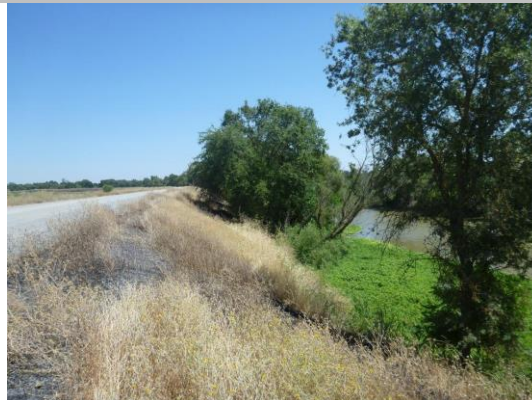
Photo 4 of 6 : LEVAL_FA_2019_182_1520.jpg

View of bank caving on the waterside slope, facing downstream. Spring 2019.

LM Start	0.73	Rating **	M	Issue No.	4 (cont)	
LM End	0.86	Issue Type +	Ma	Location *	WS	
Category	Supplemental			GPS Latitude/Longitude		
				Start	End	
Item	2017 Storm Damage			38.795769 °	38.796340 °	
				-121.736798 °	-121.738956 °	
DWR ID	RD 787-01					
Comment Code						
Inspector Comment						
Levee Evaluation Comments						
Description:						
Site ID No:182						
Site Designation:RD 787-01						
Repair Type: Erosion						
Rating:Area of Concern						
Field Date:7/18/2017						
Notes:

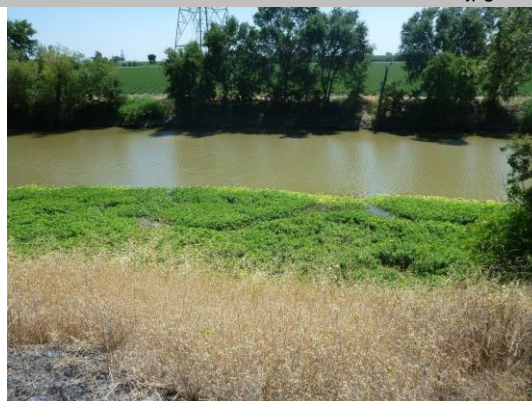
Photo 5 of 6 : LEVAL_FA_2019_182_1522.jpg

LM Start	0.73	Rating **	M	Issue No.	4 (cont)
LM End	0.86	Issue Type +	Ma	Location *	WS
